Manhole Inspection Summary

Manhole # S13WW_004MH

Insp Date: **8/1/07 11:29 AM**

Location Address: **3413 ROSEDALE RD**

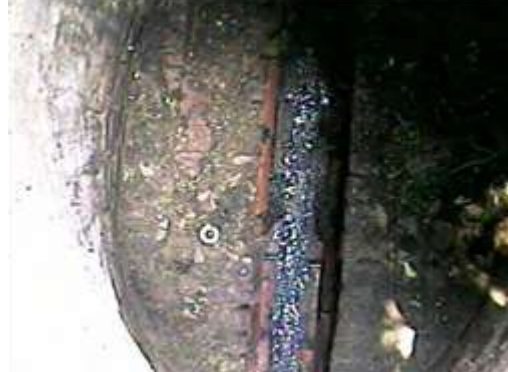
Top View

MISSING RUNG

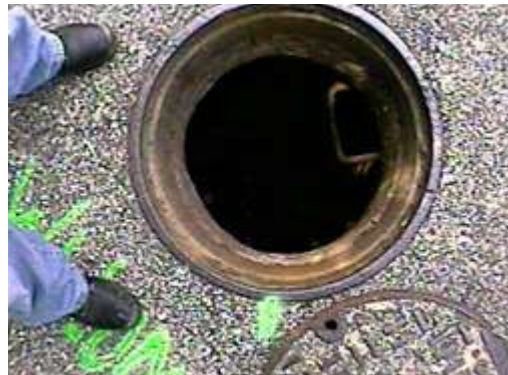
Defect 2

Frame Offset: **2** (in.) Condition: ☒ Sound ☐ Cracked ☐ Leaks

OFFSET FRAME

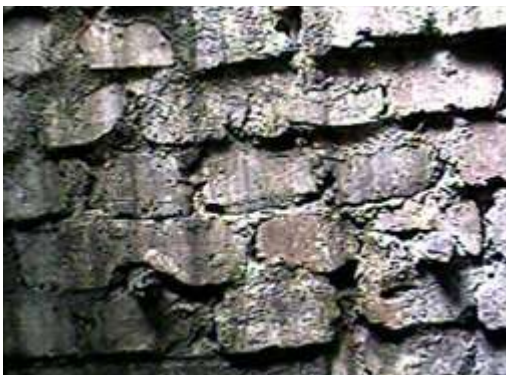
Defect 1

Steps Count: **2** Missing: **1** ☒ **Corroded**

MISSING RUNG

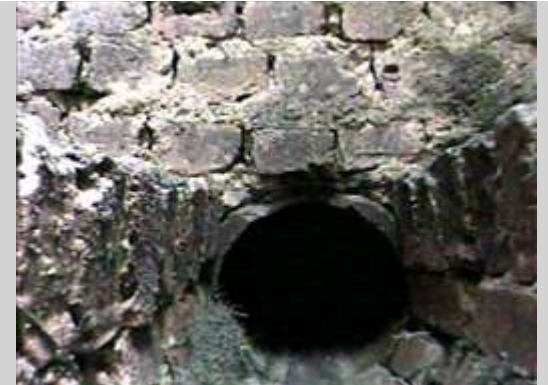
12 O'Clock Outflow

8 in. Circular Gravity Sewer
Pipe Out @ 12 O'Clock

Pipe Height: (in.) Direct
Pipe Material: **Clay** ☐ Pipe Lined
Invert Depth: **5.93** (ft.) Flow Characteristics: **Slow**
Deposits: ☒ None ☐ Mud ☐ Sludge ☐ Debris ☐ Grease
Silt Depth: (in.) Deposits Extent:
Infiltration: **None** Pipe Seal Cond: **Broken**

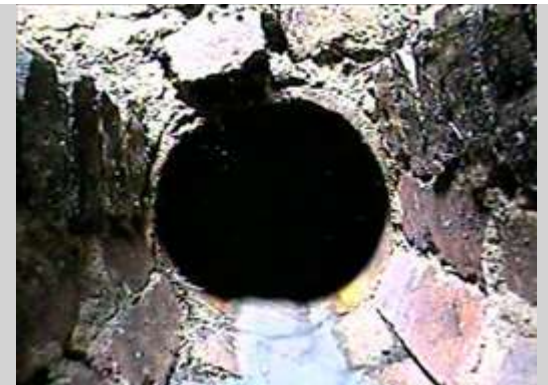
6 O'Clock Inflow

8 in. Circular Gravity Sewer
Pipe In @ 6 O'Clock

Pipe Height: (in.) Direct
Pipe Material: **Clay** ☐ Pipe Lined
Invert Depth: **5.84** (ft.) Flow Characteristics: **Slow**
Deposits: ☒ None ☐ Mud ☐ Sludge ☐ Debris ☐ Grease
Silt Depth: (in.) Deposits Extent:
Infiltration: **None** Pipe Seal Cond: **Broken**
